Conservation of water during shower with the application of sensors

Texas A&M University – Corpus Christi Honors Program

The purpose of this Project of Excellence is to apply a motion sensor to a showering assembly to conserve water. This was done by mimicking the functions of a touchless faucet to design an assembly that was applied to a stand-up shower. Thirty-six trials were done to show that water conservation is attainable through the application of sensors to a showerhead.

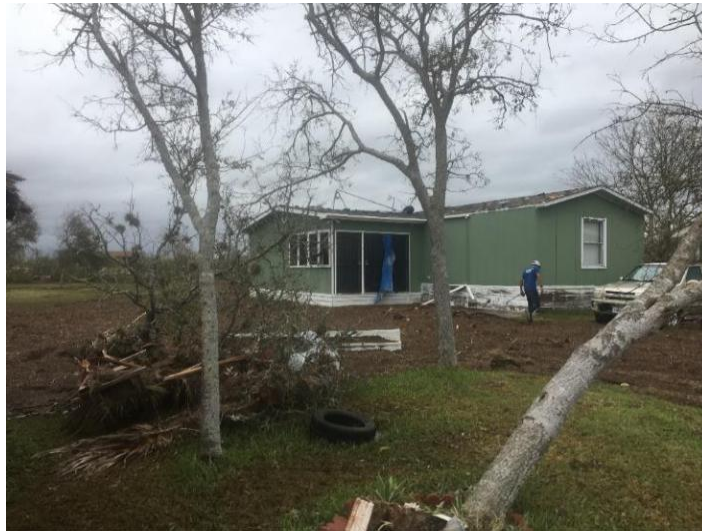
Figure 3. My home still standing Post-Hurricane Harvey.

The fact that our home was still stand was deceiving (Fig.3). It was until we went inside that we saw the actual damage. The ceilings of my mother's room, sister's room, both bathrooms and porch had collapsed. Our garage had exploded in our backyard (Fig.4). It would be several weeks before public utilities would be restored in our area because we live outside the city limits of both Rockport and Aransas Pass.

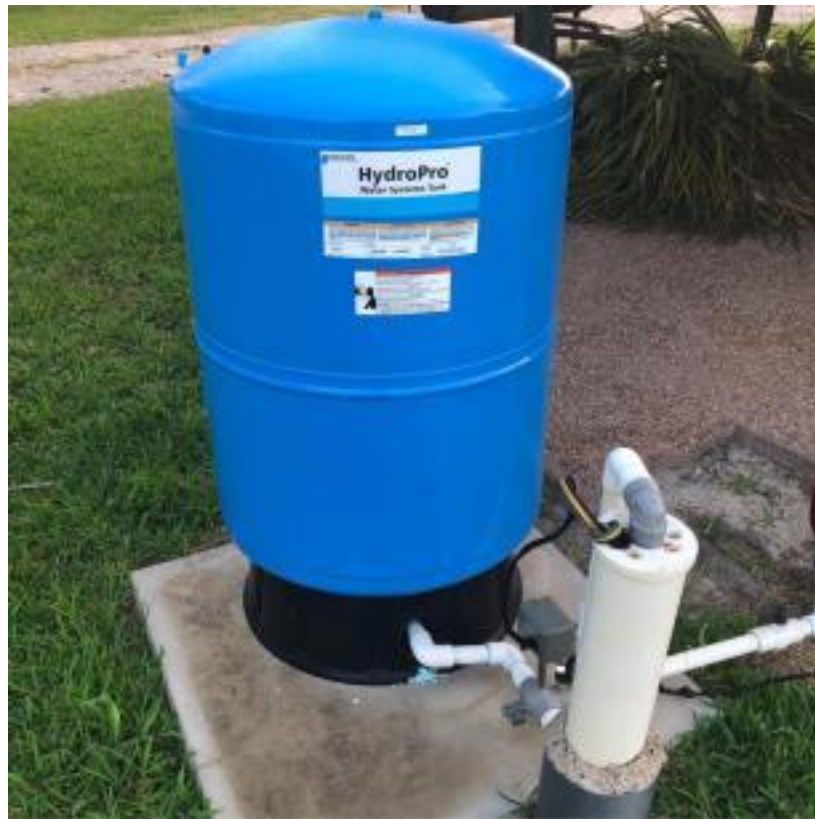
The rural⁵ area we live in has waterwell with a water pump (Fig.5) to produce water for daily use. Figure 1-5 shows a picture of the actual waterpump at my house. Our waterwell and waterpump work with electricity so during the power outage following Hurricane Harvey, there was no water. During this time, diaster relief supplied us with 5-gallon buckets to transport water. At one point we were transporting ten 5-gallon buckets to wash dishes and take showers. It was during this time that I realized I was able to shower with less than 10 gallons (two 5-gallon buckets). This realization was shocking! This is why I chose to do my Project of Excellence on research in the conservation of water.

Figure 5. *The water pump that brings water up from the ground*

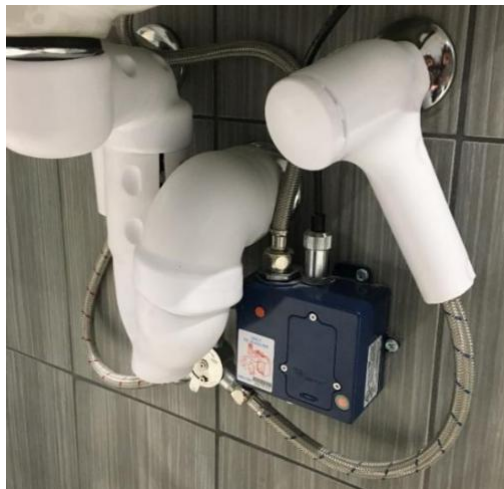
The nonvisible components of an IA motion sensor faucet are pictured in Figure 8. The components include braided water hose connector flexible tubes, a control box that houses the electronic valve and batteries. Some control boxes connect to a power outlet instead of using a battery but according to National Electrical Code requirements [20], the receptacle⁷ must be within 36 inches of the outside edge of the sink basin. Due to this code, power outlets should not be near the shower and/or bathtub, so a battery-operated control box was adaptable to this design.

Figure 8. *The underneath of a sink in a Texas A&M University – Corpus Christi restroom.*

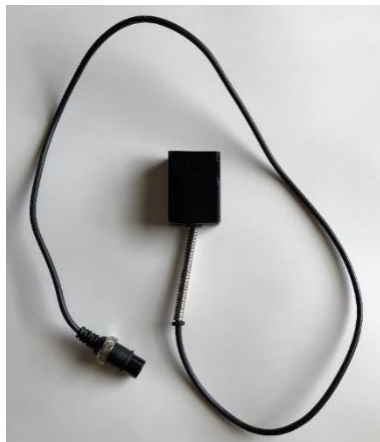
Figure 10. The IR motion sensor used for this this experiment.

box is a 6-volt, direct current (DC) input/output that requires four alkaline AA batteries that are estimated to have a cycle of 2 years at 8,000 cycles per month (Fig.9). Inside the control box is also solenoid valve of 3/8-inch compression inlet and ½-inch national pipe straight mechanical⁸ (NSPM) outlet. The IR motion sensor for this project has a range of 4 to 7 inches with a 2-foot cable to allow movement (Fig.10). These parts were ordered from overseas and do not have brands linked to them. The flexible faucet connector was purchase as Lowe's (Fig.11) and the detachable handheld shower head was purchased at Walmart (Fig.12).

The results later discussed were gathered by allowing myself as the test subject the IR motion sensor would sense. The IR motion sensor was approached from the left side, the right side and from the front. The IR motion sensor can “see” objects in a 4 to 7-inch range. The temperature and pressure of the water was regulated using a single-handle pressure balance valve knob and marked with tape so that at each trial it would be the same (Fig.14). To begin each trial, the knob was turned until it set at the beginning of the tape. A total of 12 trials per time segment (10-minute, 20-minute and 30-minute showers) were recorded; 6 segments without the IR sensor, 6 with the IR sensor. In total, 36 trials were done within the span of two weeks. The results are discussed in section 4.

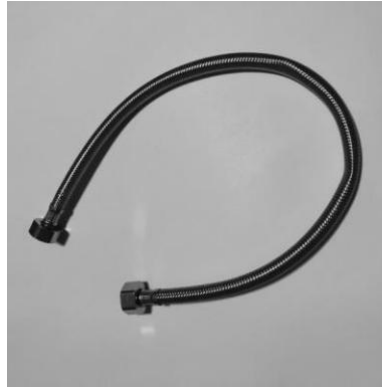
Figure 11. *The flexible faucet connector purchased at Lowe's.*

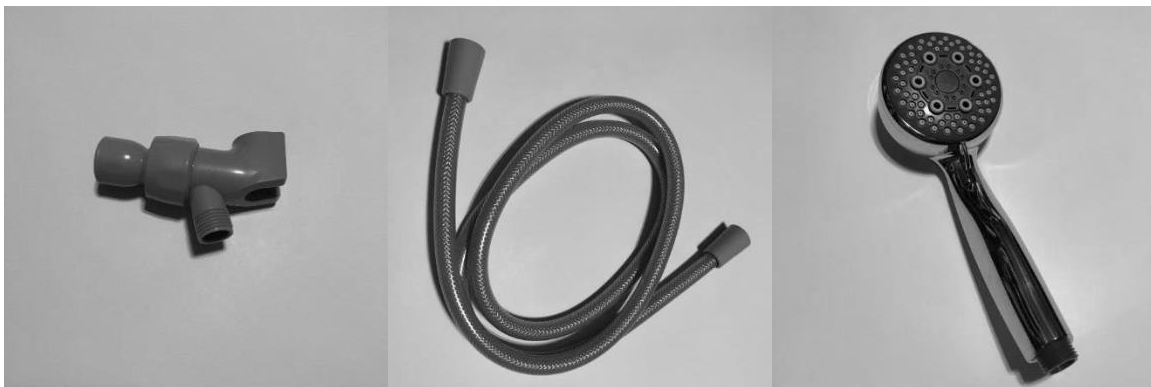
Figure 12. *The parts of the detachable shower head purchased at Walmart.*

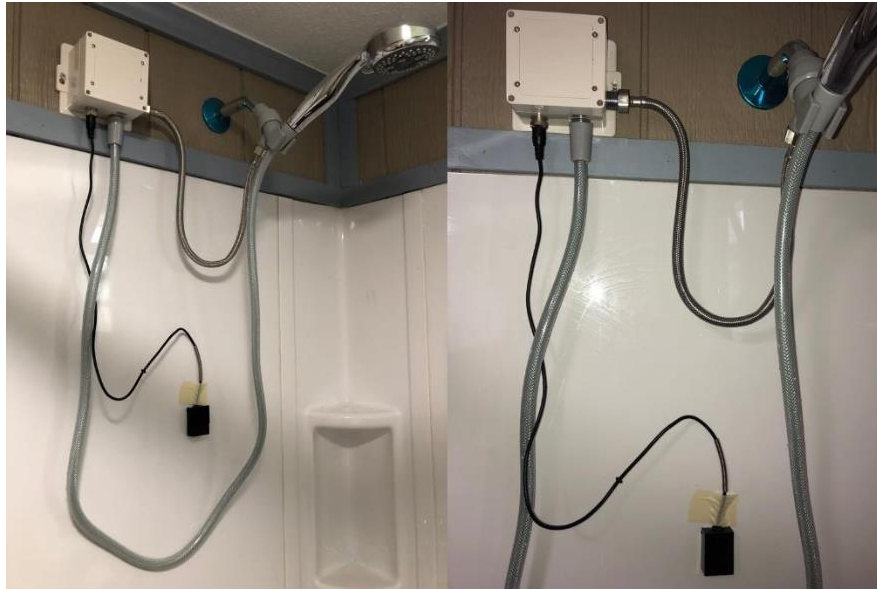
The design assembled for this research consists of five major components: Shower head, a 20 inches flexible connector hose, control box, IR motion sensor and the 60 inches hose that was included with shower head. The elbow that came with the shower head is placed at the end of the rod. The flexible connector connects the outlet of the elbow to the inlet of the control box. The 60 inches hose connects the outlet of the control box to inlet of the detachable shower head (Fig.13). The water was turned on at this point to test the connections were water tight. Water ran through the assembly freely since the solenoid valve was not regulate because the four AA batteries nor the IR motion sensor had been added to the control box yet. After adding the four AA batteries to the control box, the IR motion sensor was plugged in to the control box and further testing could continue.

Figure 13. The components assembled to create the assembly used for testing

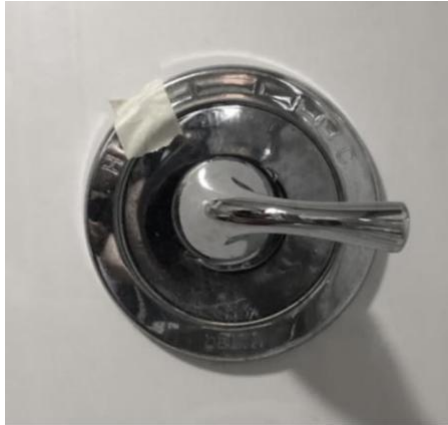
Figure 14. *The single-handle pressure balance valve knob set in “off” position.*
